Injection of Large Joints

by Peter F. Donahue, PE and
Henry A. Russell, PE

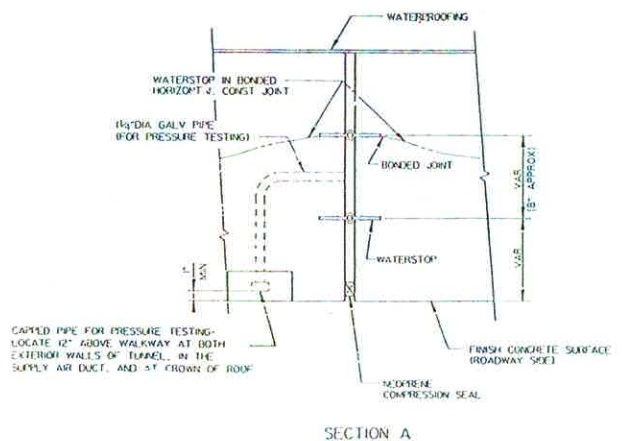
Figure 2

The joint in questions was a movement joint between two sections of cut and cover concrete box tunnel. The joint was designed as a movement joint in the range of $\frac{1}{2}$ " to $2\frac{1}{2}$ ", so injection with a cementitious grout or a rigid chemical grout could not be done. The joint was initially designed to be a $1\frac{1}{2}$ inches open and protected from leakage with two bulb-type water stops located approximately 8 inches apart running completely around the 40 foot deep by 90 foot wide tunnel section (See Figure 1). $1\frac{1}{4}$ " pipes were installed at six locations, two locations in the tunnel roof, two locations in the supply air duct beneath the roadway surface, and two locations at the roadway surface to pressure test the space between the water stops (See Figure 2).

A further review of the design of the joint and subsequent field inspection of the joint revealed that the test pipes originally installed during the construction of the joint were still in place, operational, and accessible. The optimum solution would make use of these points to access the joint rather than an expensive and time consuming drilling process since they were installed with a clear path which would allow injection of grout into the area between the waterstops.

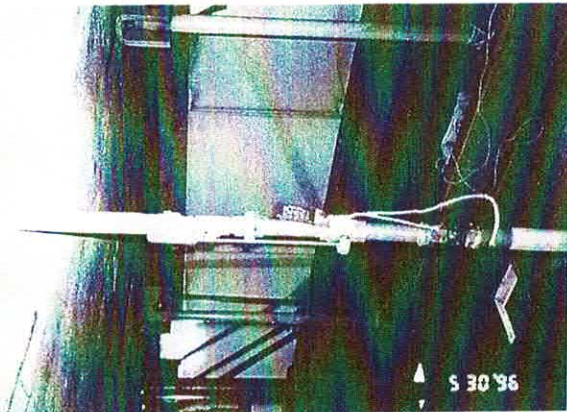
Figure 3

A Vactor Jet Rodder truck with a high capacity pressure pump and a 5000 gallon tank was used to pump water into the joint through one of the test ports in the tunnel roof. The Jet Rodder was connected to the test port with an adapter and an equivolume valve located in the exhaust air plenum above the roadway (See Figure 3). The

equivolume valve was used to control the pressure so as not to fracture the concrete lining of the tunnel. An aniline green dye was used to identify the presence of pumped water in the joint. After the pumping began, the pressure was slowly increased to 750 psi at the pump, the actual pressure at the joint was significantly less due to pressure loss in the 500 feet of hose between the pump and the test port. The calculated pressure of the water in

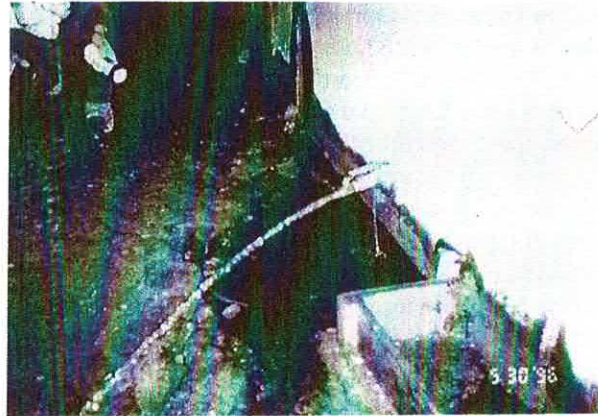
Figure 4

All of the valves on the test ports were opened and immediately after the pumping commenced, very black, organic smelling water began to flow out of the test pipes in the invert of the tunnel. After 10 minutes, green dye was observed across the roof joint in the tunnel, and after 25 minutes, green dye was observed flowing out of the test ports in the invert of the tunnel, the furthest point from the

injection port (See Figure 4). The volume of water pumped during the 25 minute period was approximately 500 gallons.

The conclusions from the test were that the joint did have sufficient connectivity to make the use of the test ports a viable repair option. Also, the volume of chemical grout required to fill the joint would be approximately 500-600 gallons.
