Injection of Large Joints

by Peter F. Donahue, PE and
Henry A. Russell, PE

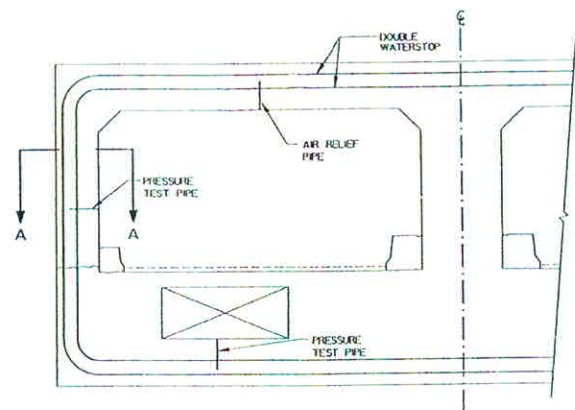
Figure 1

The joint in questions was a movement joint between two sections of cut and cover concrete box tunnel. The joint was designed as a movement joint in the range of $\frac{1}{2}$ " to $2\frac{1}{2}$ ", so injection with a cementitious grout or a rigid chemical grout could not be done. The joint was initially designed to be a $1\frac{1}{2}$ inches open and protected from leakage with two bulb-type water stops located approximately 8 inches apart running completely around the 40 foot deep by 90 foot wide tunnel section (See Figure 1). $1\frac{1}{4}$ " pipes were installed at six locations, two locations in the tunnel roof, two locations in the supply air duct beneath the roadway surface, and two locations at the roadway surface to pressure test the space between the water stops (See Figure 2).
